PEAK OF FLIGHT

Issue 606 / August 15th 2023

Zephyr Repair After a Motor CATO By David Anisman

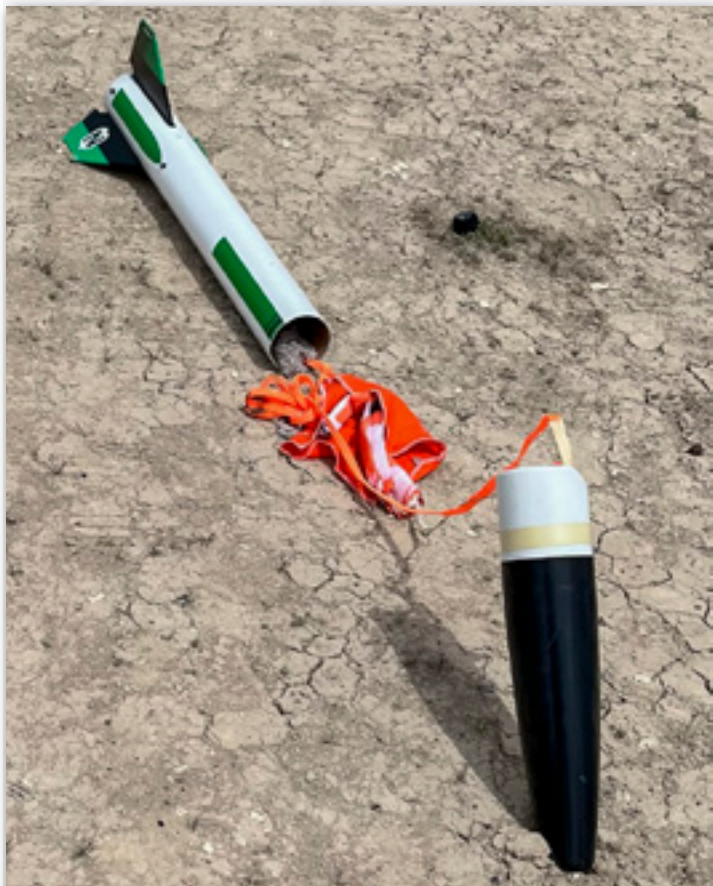
As bummed as I was, I was also determined to learn from whatever happened and recover from it to fly again. At this point, there can be a real desire to go grab the rocket and take it back to your prep area to do a postmortem. But the first step should be a thorough inspection of the crash site (Fig 1) as it may provide some key clues to what transpired. At the crash site, the only obvious damage I could see was that the aft end of the motor mount tube, with its attached Aeropack retainer, had separated from the rocket and was lying next to it. Otherwise, the body tube appeared to have survived without buckling and the all important fin can seemed fine. Certainly a lot better than I'd expected!

Figure 1: Zephyr at crash site

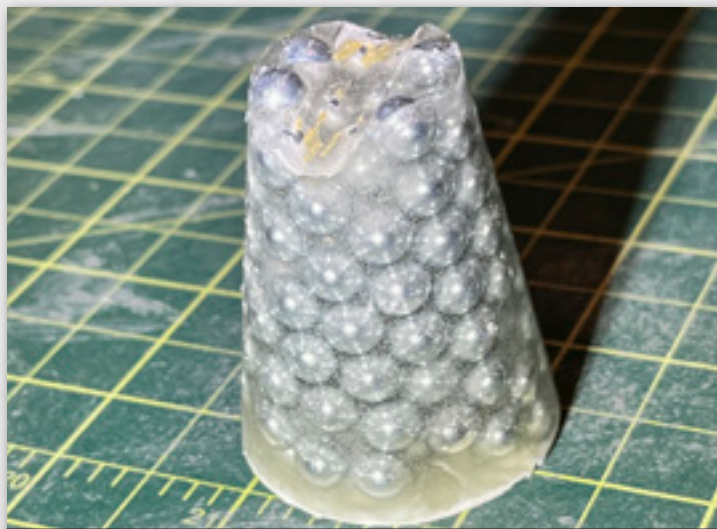
Figure 2: Broken nose weight from the crashed Zephyr

Back at the prep area, I confirmed that the rocket framework - body tube, fins/fin can and nose cone - were entirely intact (!)... a tribute to the engineering Apogee put into this rocket and, I must say, me - for following directions! The two areas of major damage were the nose cone weight and the motor mount tube. I had put in nose weight using a dowel through the nose cone tip and pouring a slurry of epoxy and BBs to surround the dowel (Apogee Advanced Construction Video #84, https://www.apogeerockets.com/Advanced_Construction_Videos/Rocketry_Video_84). The weight broke just aft of the dowel, leaving the dowel and the forward portion of the weight place and allowing the aft portion to rattle around freely in the nose cone (Fig 2). This loose weight would no longer serve its purpose, but more concerningly would also be a destabilizing factor during flight. That would need to be removed before the rocket would be safe to fly.

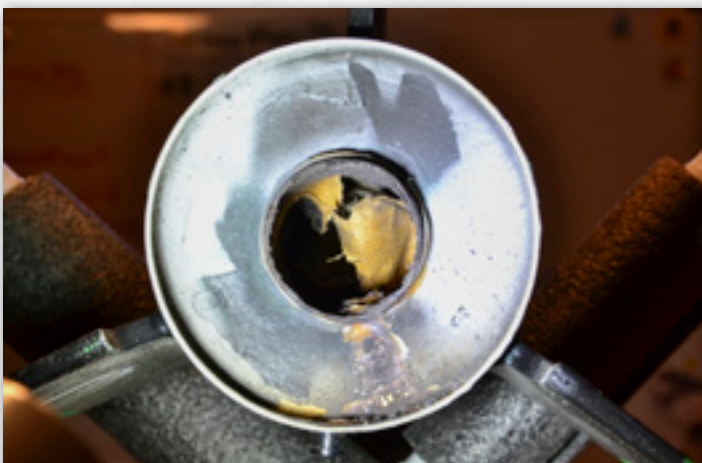
Figure 3: The damaged motor mount tube

Sadly, the motor mount tube was severely damaged. There was molten remains of the motor liner inside it; it had been perforated and had also collapsed over about half its length. It was clearly beyond repair (Fig 3). It would need to be removed and replaced if this rocket would ever fly again.

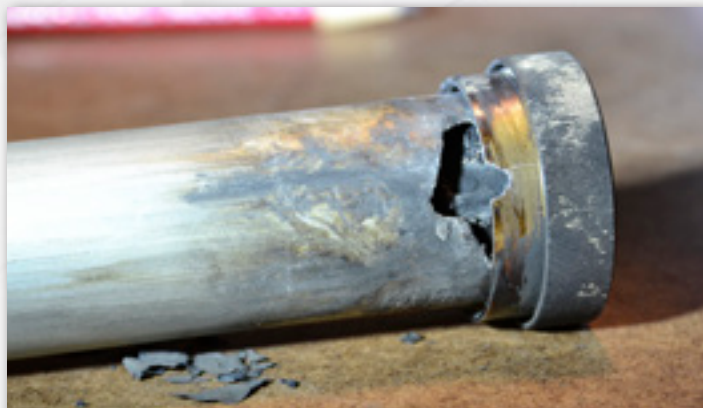
So what exactly happened? As best I can put it together, the primary cause of the CATO (catastrophic failure) was a defect in the motor liner, just forward of the

Figure 4: A defect in the motor liner likely leading to the CATO

aft closure (Figs 4 & 5). As a result, instead of all the thrust being directed out axially through the nozzle, the defect allowed thrust to be vented sideways. This super hot thrust burned through the casing and motor mount tube and resulted in vectored thrust. The summed vector of (weakened) axial thrust and quite powerful lateral thrust was probably at a 60 degree angle to vertical, which caused the rocket to cartwheel. It also caused the aft end of the motor mount tube with its Aeropack retainer to

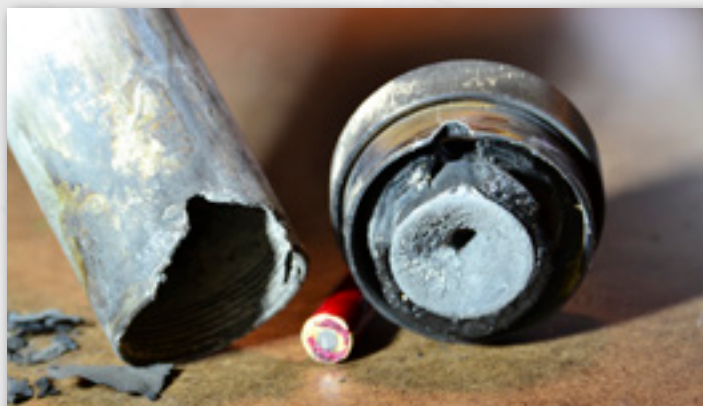
Figure 5: Another view of a defect in the motor liner likely leading to the CATO

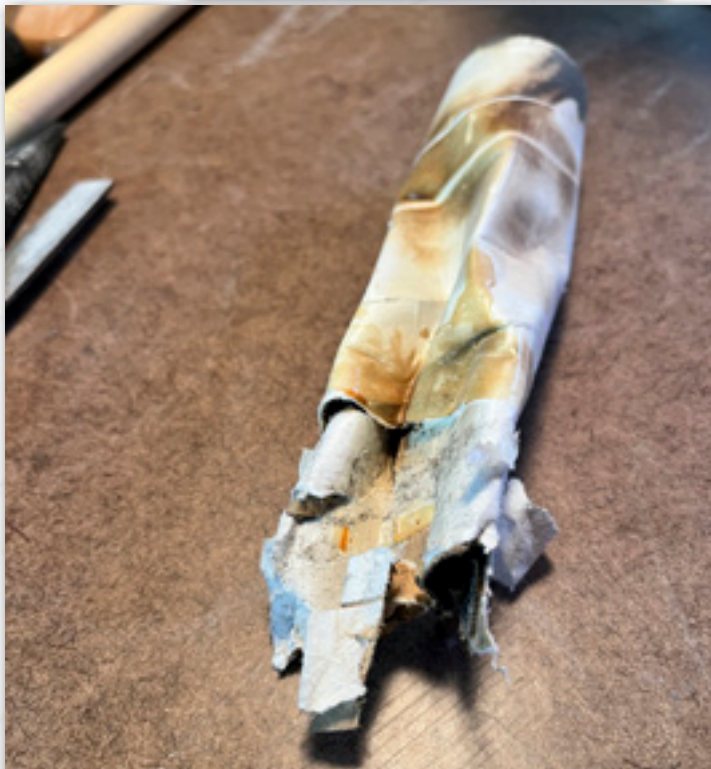
Figure 6: The resulting motor tube after being removed

wall and collapse of the middle half of the motor mount tube. I was actually able to pass a long dowel from the aft end of what remained of the motor mount tube, through the breach in the tube and into the body tube cavity forward of the forward centering ring, without going out the forward end of the tube! I did attempt to use the dowel to re-expand the motor mount tube, but it was sealed in the collapsed state by the molten motor liner that had extruded through the breach in the casing. Clearly, the motor mount tube could not be salvaged or repaired and had to be replaced. I was able to reach in for the forward end of the body tube and pull out the motor mount tube as the epoxied joints had largely burned away (Fig 6).

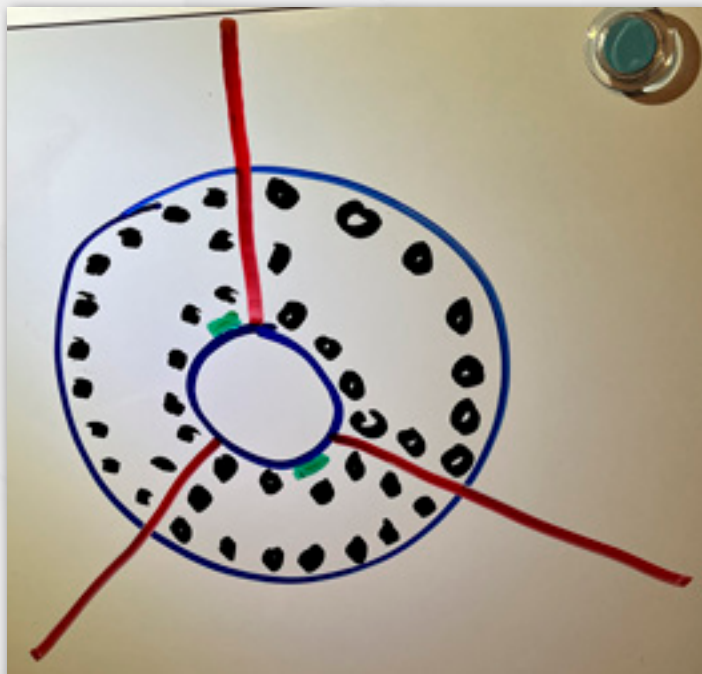
Figure 7: Zephyr schematic to determine where to safely drill

lutely certain that I knew what was behind that aft centering ring, and where everything was, so that in removing it, I could be as precise as possible. I drew a schematic (Fig 7) showing where I could safely drill (black circles) and where I could not drill (green squares). The green squares were the alignment rails, whose original purpose was to make sure the fin tab slots on the aft centering ring were perfectly aligned with the corresponding slots on the forward centering ring. It seemed to me I wouldn't need the rails any longer since the fins were already in place. But as the figure shows, the alignment rails sit very close to a fin tab, and I elected not to try to drill into the rails in order to be sure I wouldn't inadvertently damage a fin tab.

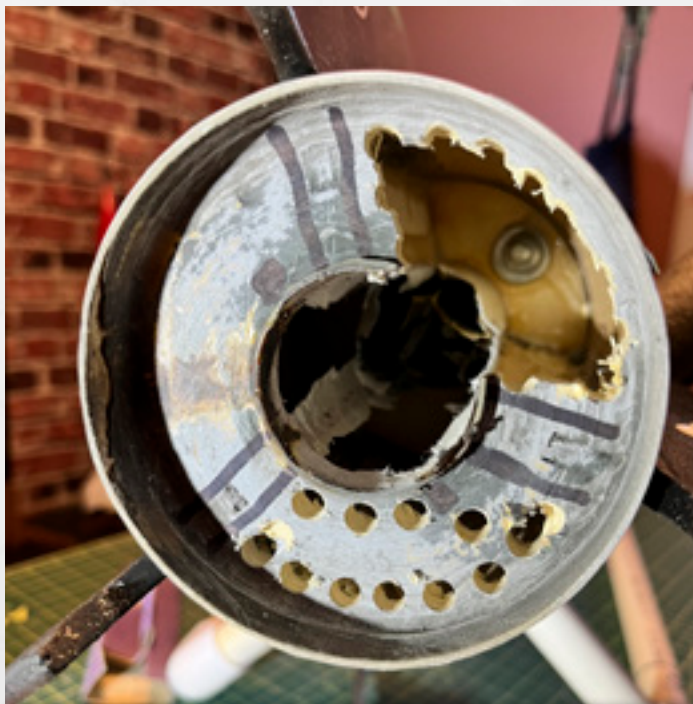
Figure 8: Step 1 of holes being drilled to remove the aft centering ring

After drilling the holes, I used a keyhole saw to cut out the wedges of centering ring (Figs 8-10). This wasn't easy, as the saw, which was the finest one I could find (14 teeth per inch) tended to grab the wood; a light touch, short strokes and patience were the key to cutting through with control. I then ground down what was left of the aft centering ring (Fig 11) with a Dremel and several different bits. A one inch diamond cutting disc was small enough to use inside the fin can opening without damaging neighboring surfaces, but I had to go very slowly (and use two hands!) to keep it under control. A coarse (60 grit) sanding drum was also great, but required care to keep under control and was limited in that it couldn't get into sharp corners, like

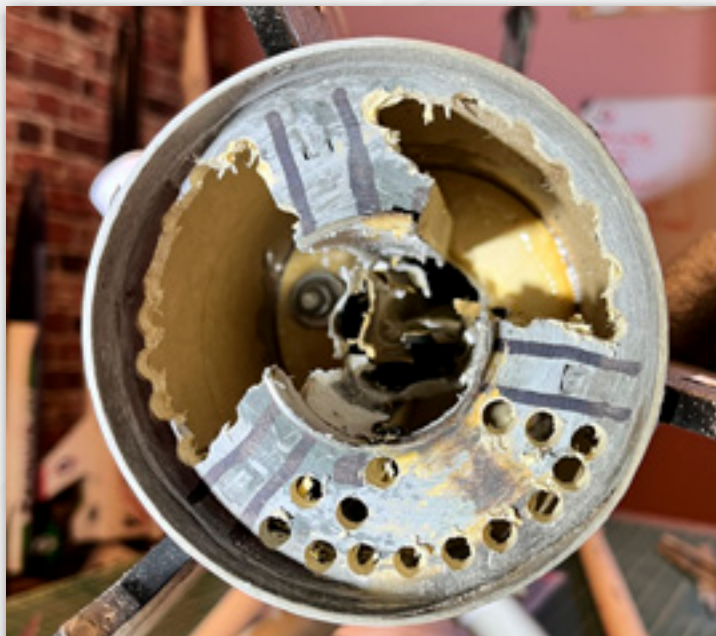
Figure 9: Step 2 of holes being drilled to remove the aft centering ring

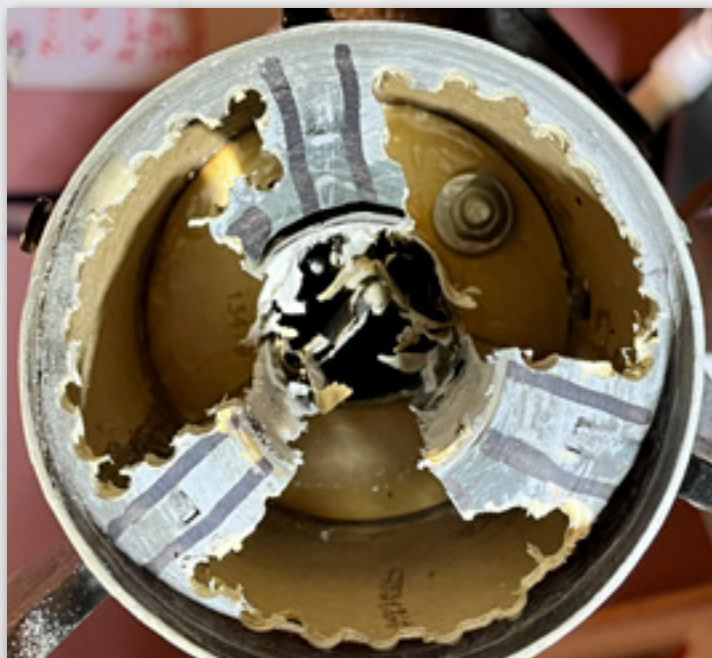
Figure 10: Step 3 of holes being drilled to remove the aft centering ring

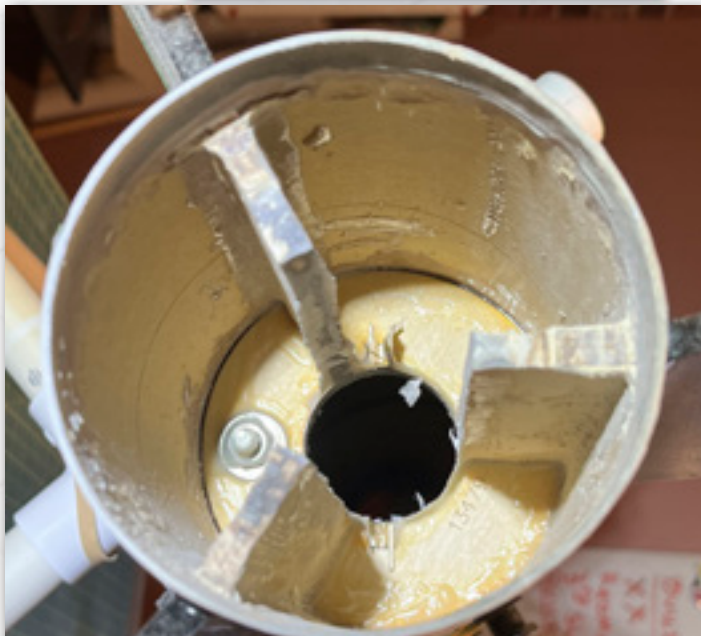
Figure 11: Aft centering ring fully removed

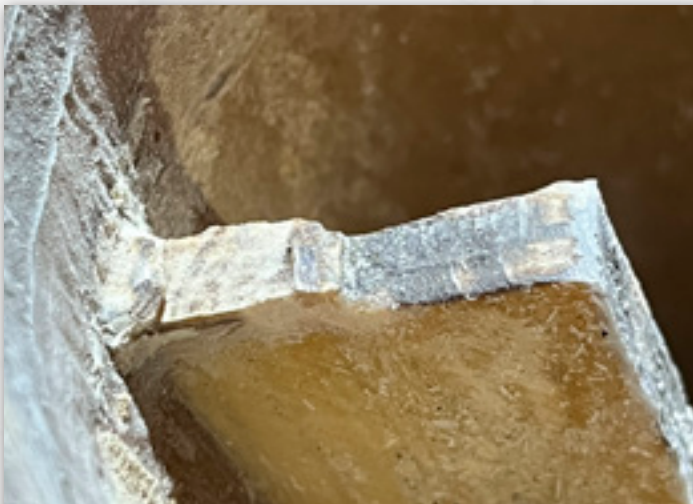
between a fin tab and the body tube. This last problem was solved by using a 1/8" drill bit - carefully! - using the side of the bit as a grinder. The aft edge of the fin tabs had a tab which fit into notches in the original aft centering ring, (Fig 12) to preserve the correct orientation of the centering ring with the fin tabs. As this orientation was no longer relevant (the fins were already glued in place), I decided not to keep the tabs, as cutting a new set of centering ring notches would be difficult (and I was determined to do this without ordering a replacement centering ring....which Apogee does sell).

Figure 12: Closeup of the fin tab for aft centering ring alignment

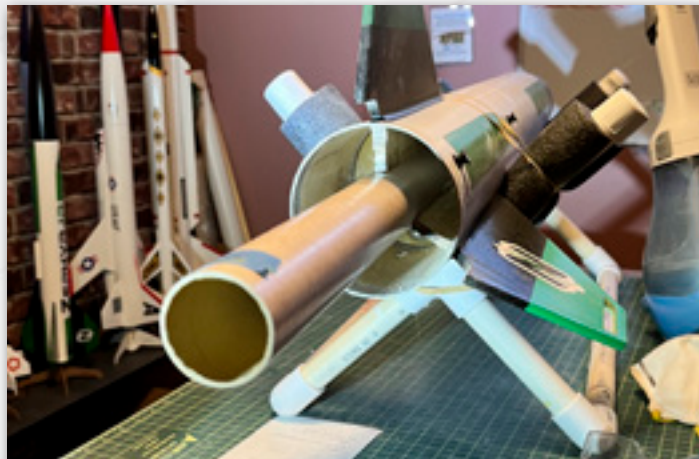
Figure 13: Replacement tube for motor mount

The next step was to test fit a thick-walled 38mm tube to see if the channel for a new motor mount tube was the right size. Here, I proved lucky: the new tube fit in smoothly all the way past the forward centering ring, and fit snugly as well. This meant that no additional major work would be necessary other than routine clean up to get the new motor mount tube in place (Figs 13 & 14). This was a real stroke of luck, as further reconstruction deep inside the fin can would have proved quite difficult.

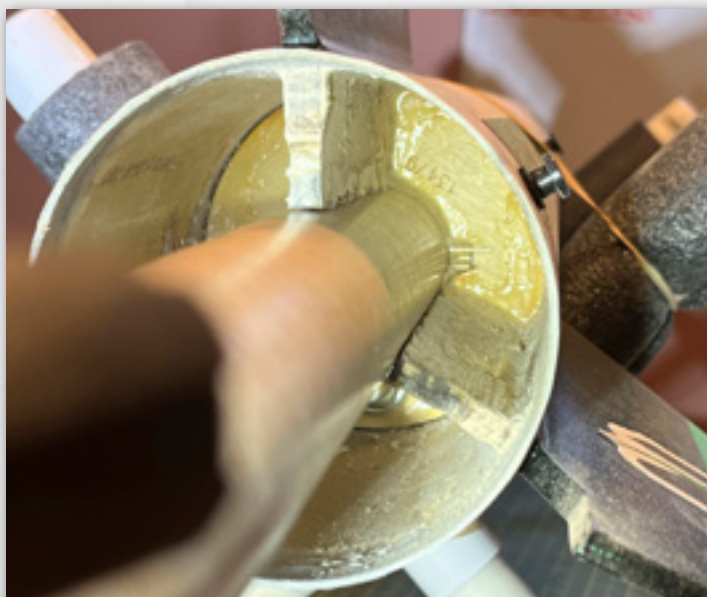
Figure 14: Closeup of replacement tube for motor mount

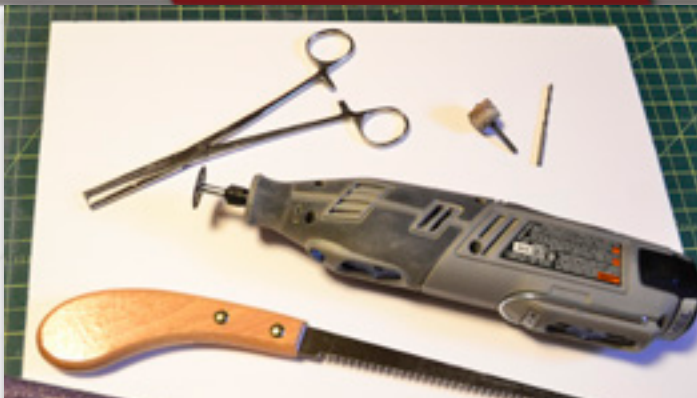
Figure 15: Hemostat on top left

glued into the forward centering ring, and I definitely didn't want to damage that ring! I could grind down some of the rails with Dremel attachments, but ultimately I had to reach into the fin can with a hemostat (the silver clamp thingy in Fig 15) and pry away the rails until most of them were gone. I did have the option to just snip off the aft end of the rails with a diagonal cutter tool, as the rails really wouldn't be in the way when replacing the motor mount tube. But this would leave unnecessary weight in the fin can, so I decided to remove them.....carefully!

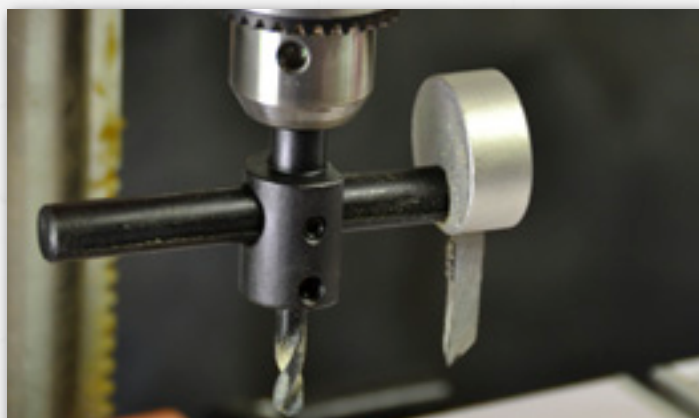
Figure 16: Circular cutting bit used to cut new aft centering ring

To create a new aft centering ring, I used 3-ply 1/8" plywood. My first attempt was to cut one on my jig saw, but the result wasn't a very true circle and required a lot of sanding; even then, it didn't really fit properly. A better option was to use a circle cutting bit on my drill press (Figs 16 & 17); since I'm always looking for an excuse to buy a new tool, this seemed the ideal solution! (Amazon, MIBRO Heavy Duty Circle Hole Cutter, \$12). This tool

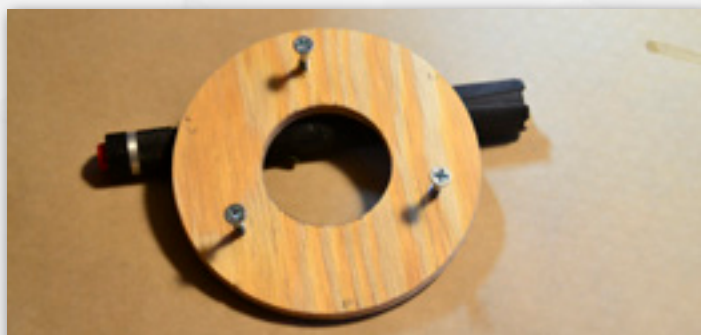
Figure 17: New aft centering ring

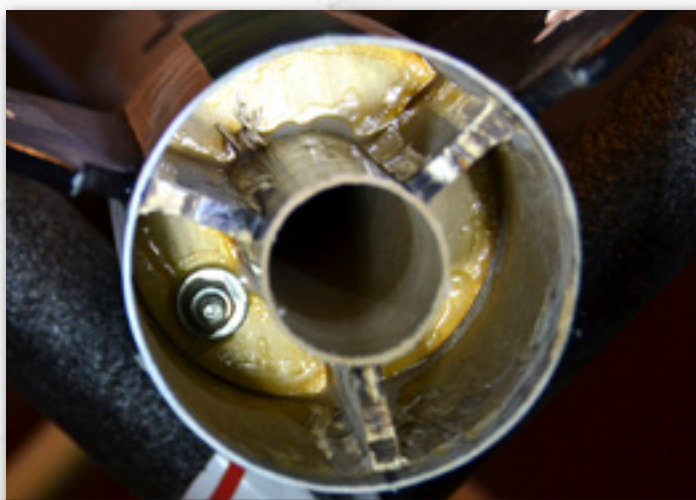
Figure 18: New motor mount tube installed

I had some spare 38mm thick walled MMT (38mm LOC Body Tube purchased from Apogee - https://www.apogeerockets.com/Building_Supplies/Body_Tubes/High_Power_Tubes/38mm_LOC_Body_Tube) from a scratch build; I cut an 11" piece (ensuring I had enough to attach a new Aeropack retainer) and it fit perfectly (Fig 18). To glue the new motor mount tube in place, I used a similar two-step procedure as in the original instructions, but with slight modifications as the fins were already in place. First, I drew lines on the motor mount tube corresponding to the fin locations using an aluminum angle; I made sure these lines extended all the way to the aft edge of the tube so they'd be visible during the initial motor mount tube glue in. Next, I ran a bead of epoxy on the motor mount tube

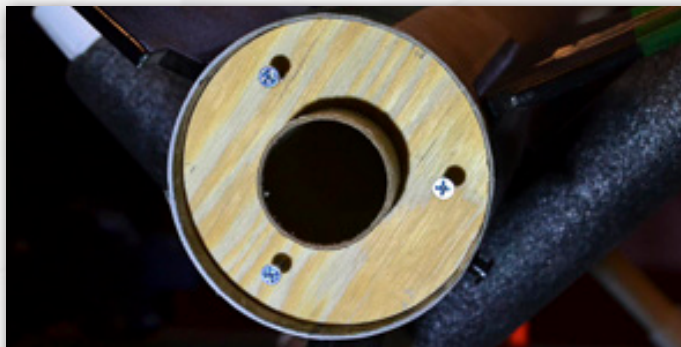
Figure 19: Centering ring glued into place

between the root edge of the fin tab and the motor mount tube. Once this was dry, I removed the aft centering ring and applied some epoxy where needed to the motor mount tube - centering ring and motor mount tube - fin tab joints (Fig 19). I then epoxied the aft centering ring into place. Lastly, I epoxied on a new Aeropack retainer and

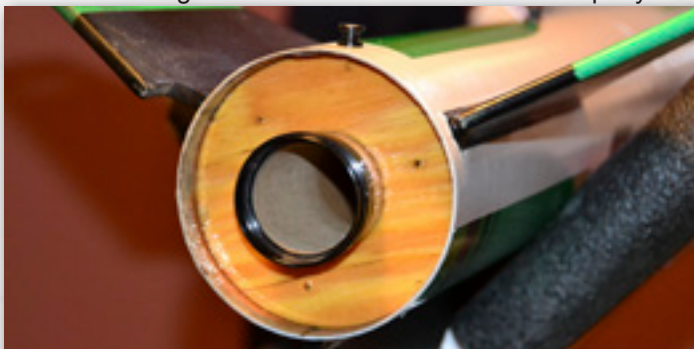
Figure 20: Completed replacement of centering ring and motor mount

put a thin coat of epoxy over everything (except the retainer), followed by a final coat of paint (aesthetics!). Fini! (Fig 20)

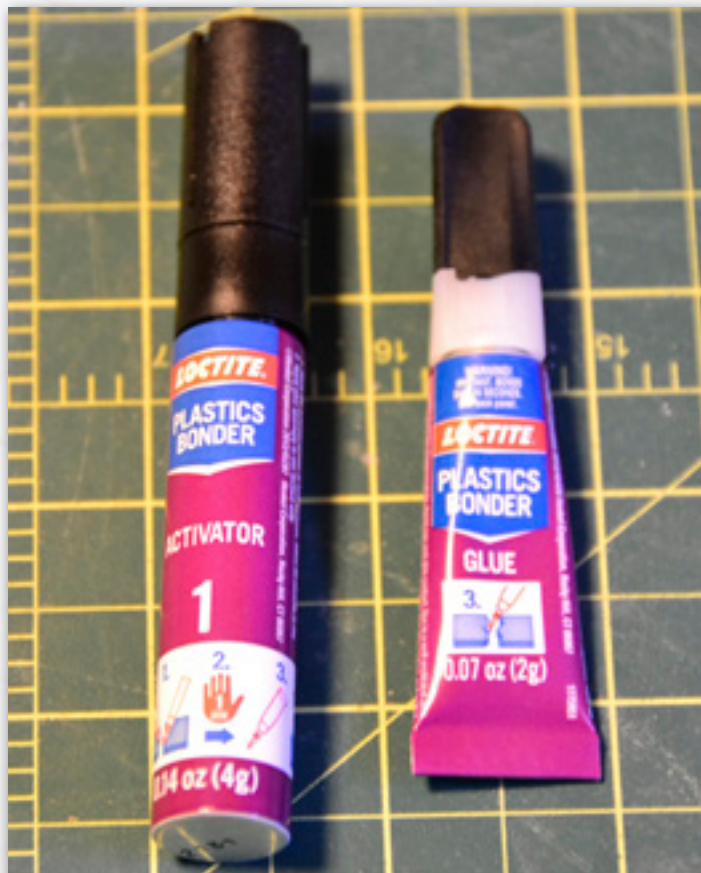
Figure 21: Loctite Plastics Bonder

adhesive that would adhere to polypropylene and found Loctite Plastics Bonder (Fig 21), a 2-part set up with an activator that is applied just prior to the actual glue. (Note: I subsequently spoke to other rocketeers who said that most epoxies will work fine to glue a plywood bulkhead into the nose cone if you rough up the surfaces to be bonded and have a good, snug fit; this can be reinforced with small wood screws. But by that time, I'd already completed my repair)

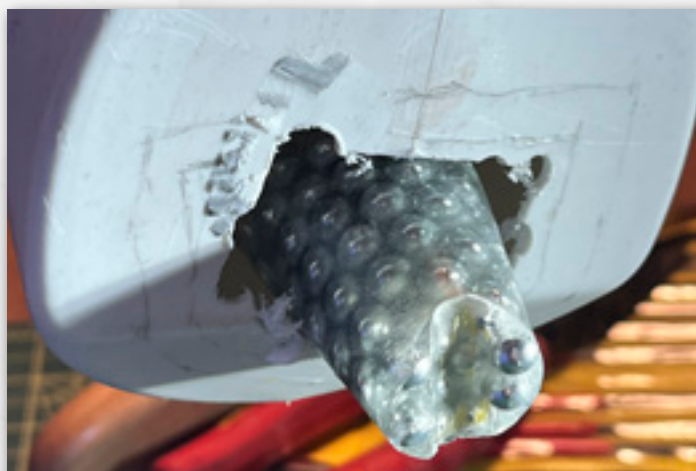
Figure 22: Nose weight is larger than the hole

In the end, I had to cut a larger hole to get the epoxy/BB weight fragment out (Figs 22 & 23). I decided to fill the hole using two shaped pieces of 1/8" plywood, one of which would hold the eye bolt to replace the shock cord/shroud line attachment point (Fig 24). The position of the hole was chosen so I could have the new shock cord attachment point on the flat area of the repair (rather than on the sloping shoulder). The two pieces of plywood were beveled slightly (using a jigsaw) to get a better fit, but the small area in which I had to work meant that it was hard to maneuver the pieces into the hole. I also wanted to be able to compress the pieces against the inside of the nose cone plastic while the adhesive grabbed. To do that, I relied on the eye bolt for the semi-circular piece and

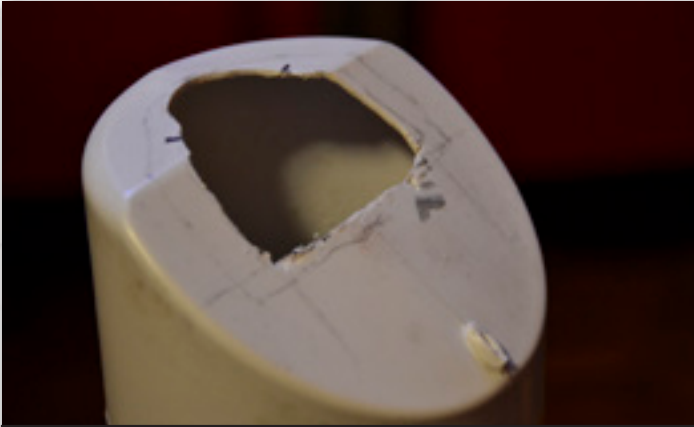
Figure 23: Hole was enlarged to remove the weight

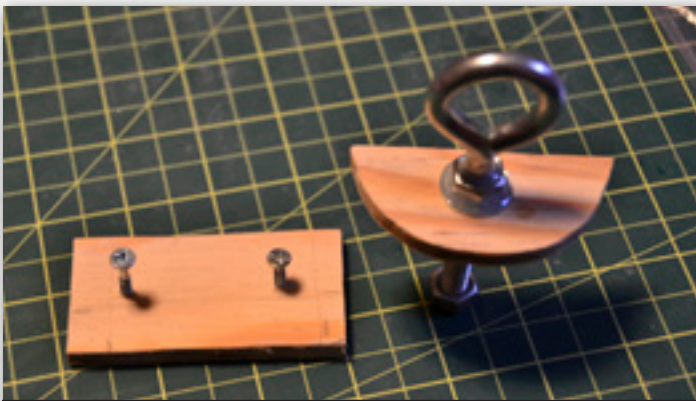
Figure 24: Replacement attachment point

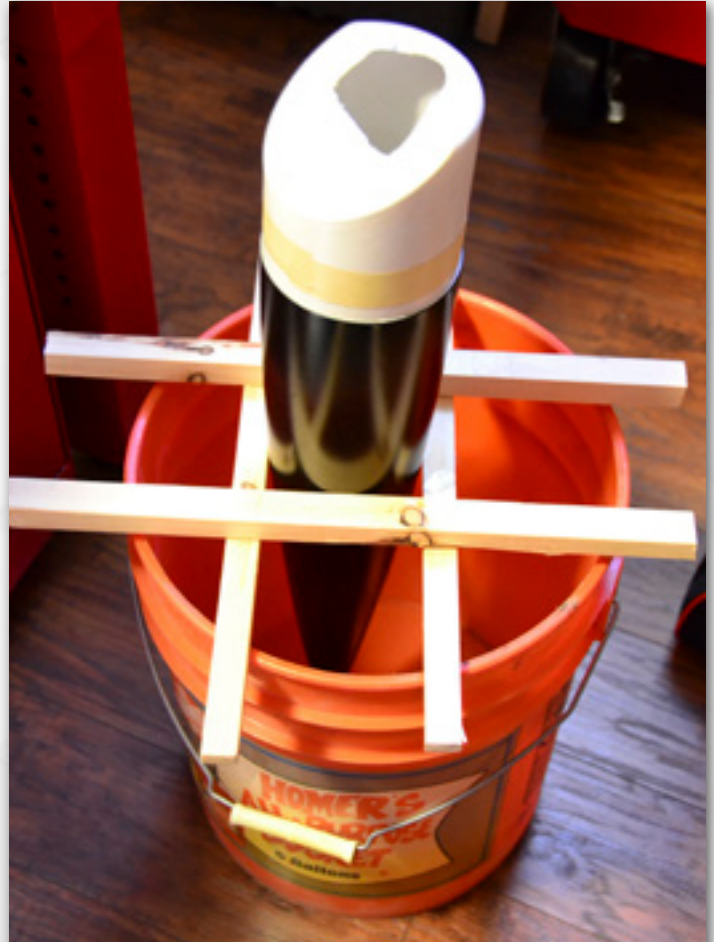
Figure 25: Nose cone suspended for fixing

put in two small wood screws to the rectangular piece, ensuring that they were positioned inside the perimeter of the hole. I also needed some way to support the NC while my two hands were busy gluing in the plywood pieces. I crafted a simple support out of some spare furring strips, gluing them into a grid that rested on top of a 5 gallon bucket. The square hole in the middle was sized to fit the nose cone securely (Fig 25). Before attempting to glue the pieces in place, I did several dry fit rehearsals so I knew exactly how to manipulate each piece into the proper position.

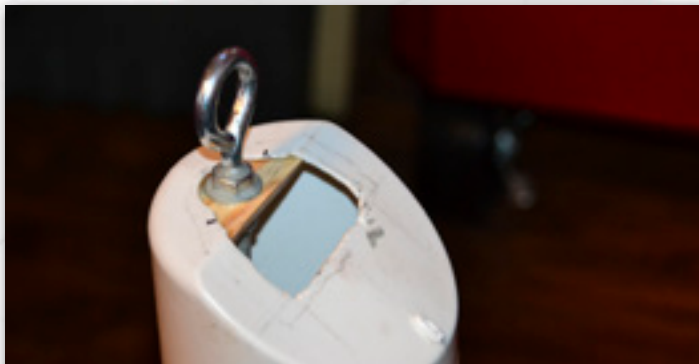
Figure 26: Step 1, the main attachment point was installed

Gluing in the pieces had one other tricky part: the glue is a thick liquid that was easy to apply on the surface of the plywood piece before maneuvering it into position. But the activator tube is like a felt tip marker and has to be applied to both surfaces before applying the glue; getting it on the inside of the nose cone plastic was awkward. I glued in one piece at a time, applying upward pressure (on the eye bolt and screws, respectively). Once the two pieces were glued in using the Loctite, I drilled pilot holes and used 3/4" screws around the perimeter of the repair to reinforce the entire

thing. Gaps in the mid-line plywood joint were filled with thick CA (Figs 26, 27 & 28).

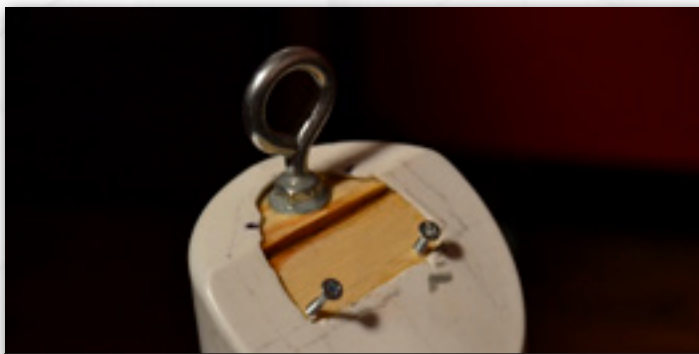
Figure 27: Step 2, a filler piece was added to close the hole

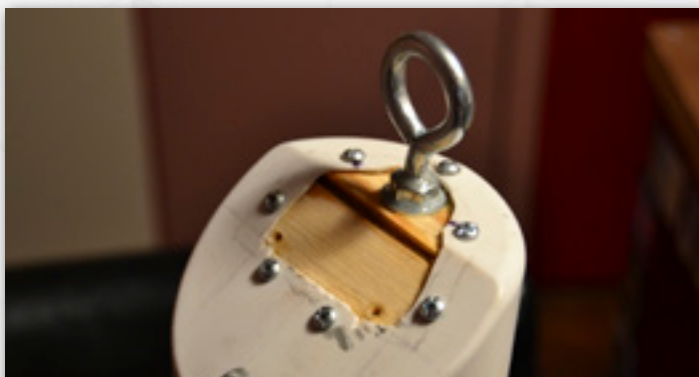
Figure 28: Step 3, both added pieces are secured
